ITEM FOR ENVIRONMENTAL BOARD AGENDA

STONERIDGE

SP-2013-0096D

On the August 7, 2013 agenda is a request for the consideration of one variance from LDC 25-8-65- to omit the roadway deduction in the calculation of allowable impervious cover for the Stoneridge commercial/office development.

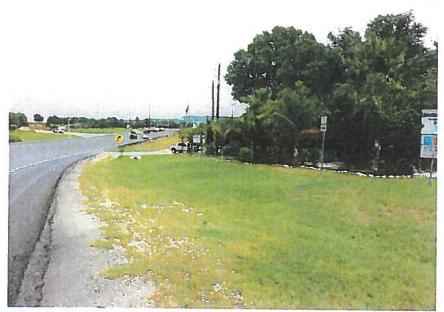
North perimeter frontage along FM 2244 to traffic light

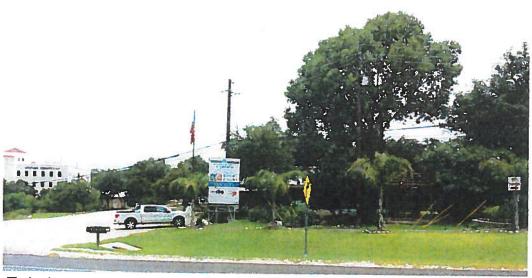
Existing commercial development onsite

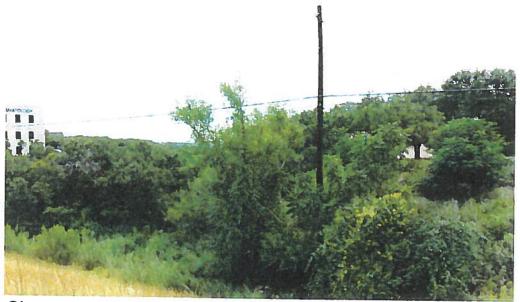
Slope areas on east side of property looking south

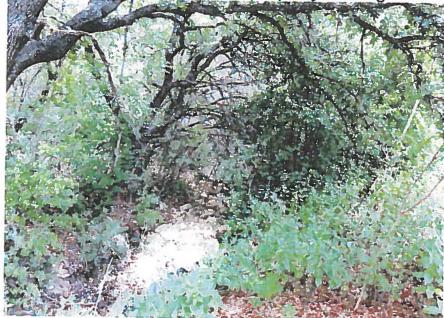
Unclassified tributary on east part of the site looking south

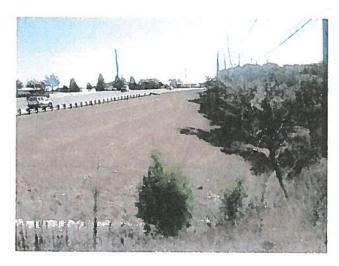
Figure 4 Drainage/Gaurdrail ROW

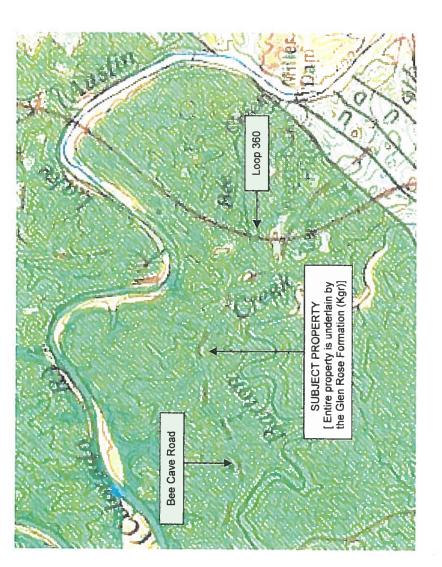
GENERAL GEOLOGIC MAP FIGURE 5

NOTE: Property location is approximate

Given the soil cover on the subject property, only broken (loose) exposed rock fragments of the Glen Rose as well as isolated areas of true rock outcrops were observed, primarily along slope breaks. These geologic materials were observed to be comprised of light gray, hard to medium-hard limestone as well as medium-hard marly material (refer to photograph in Appendix B). The greatest concentration of exposed outcrops was observed just east of the development area – along the topographic slope break.

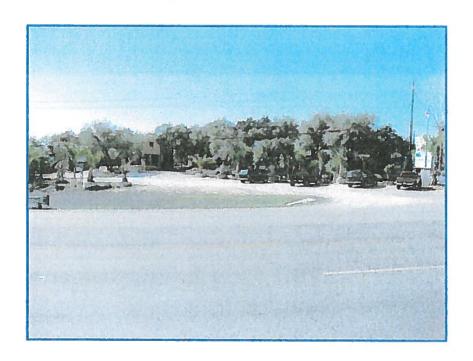
PHOTOGRAPHIC REPORTING DATA SHEET [PHOTOGRAPH 1]

Photograph taken from Bee Cave Road facing south.

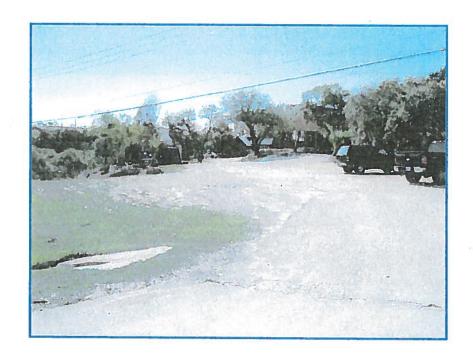
PHOTOGRAPHIC REPORTING DATA SHEET [PHOTOGRAPH 2]

taken from Bee Cave Road facing south-southeast.

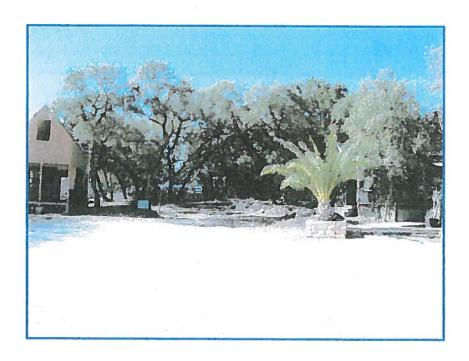
PHOTOGRAPHIC REPORTING DATA SHEET [PHOTOGRAPH 3]

of the subject property.

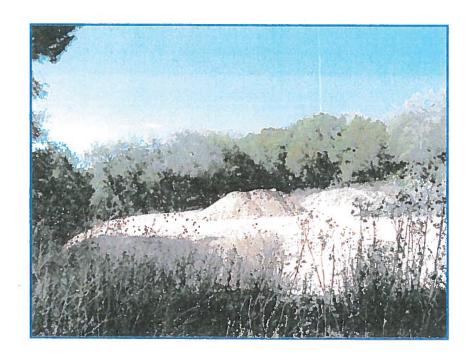
PHOTOGRAPHIC REPORTING DATA SHEET [PHOTOGRAPH 4]

of the subject property, and clearing/soil storage area.

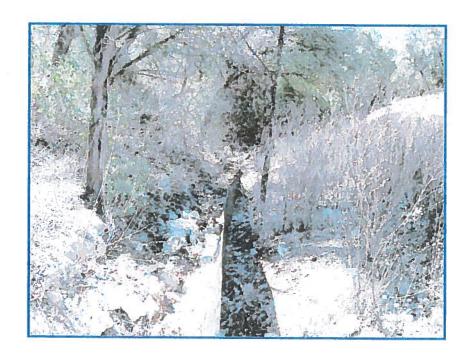
PHOTOGRAPHIC REPORTING DATA SHEET [PHOTOGRAPH 5]

subject property.

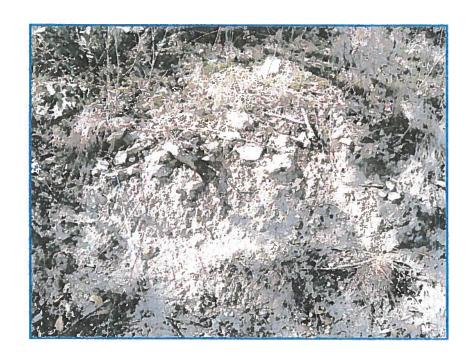
PHOTOGRAPHIC REPORTING DATA SHEET [PHOTOGRAPH 6]

View of typical soils on the subject property.
